INVENTORY FORM FOR STATE HISTORIC SITES SURVEY

Queen Anne's National Bank; Centreville Town Hall

Centreville

QA-308

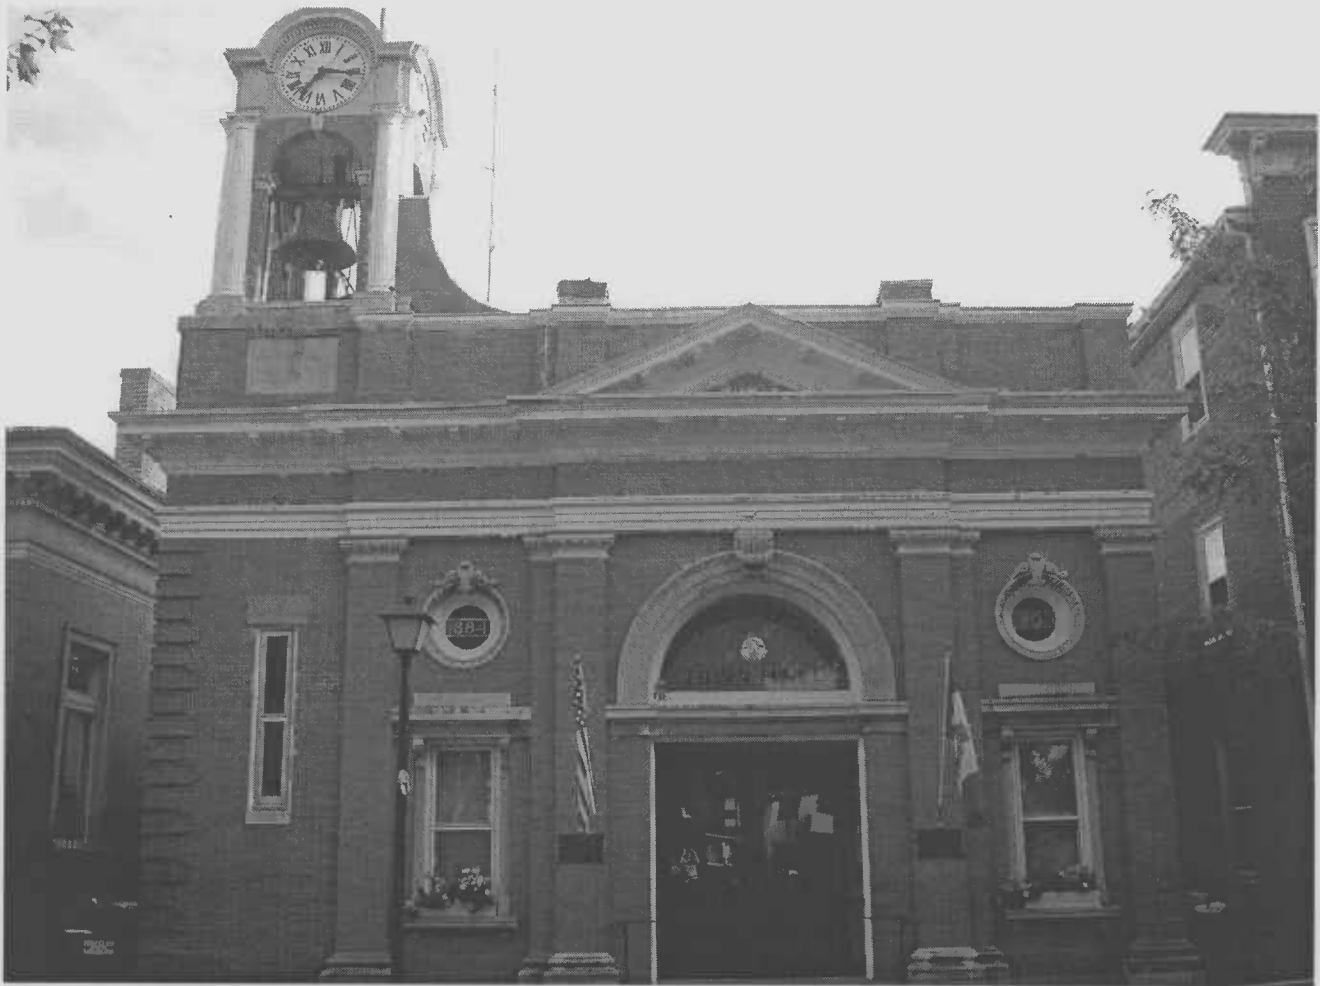
QA-308

Queen Anne's
National Bank

Mary McCarthy
Spring/Summer 2003
Digital color photo on file at MHT

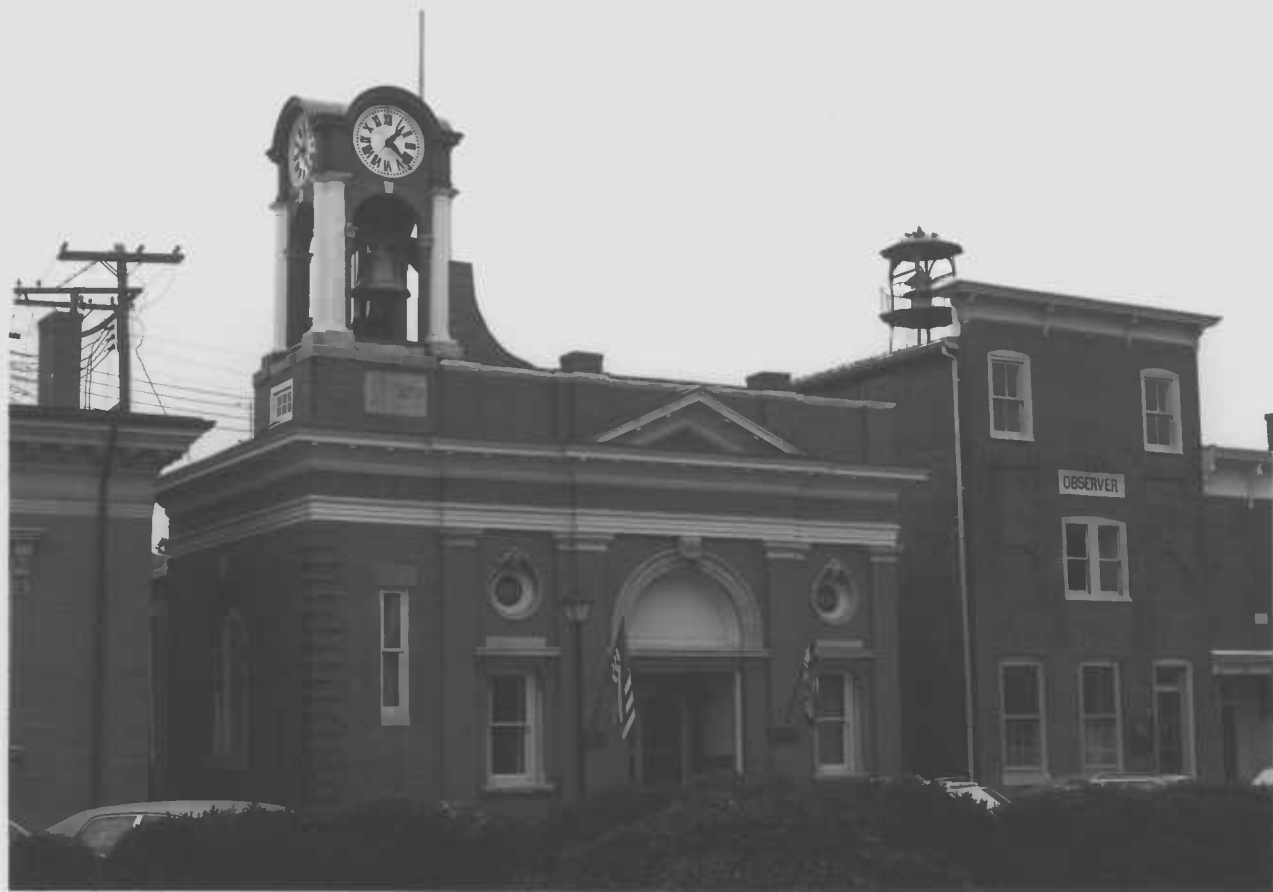
QA-308 Centreville Town Hall
(Queen Anne's National Bank)
Lawyers Row
Centreville, Maryland
Orlando Ridout V 1980
View from Northeast
